Measure Name: Automatic pedestrian gate

Definition: Installation of automatic pedestrian gates at active grade crossings.

FRA Grade Crossing Toolkit: Automatic pedestrian gate

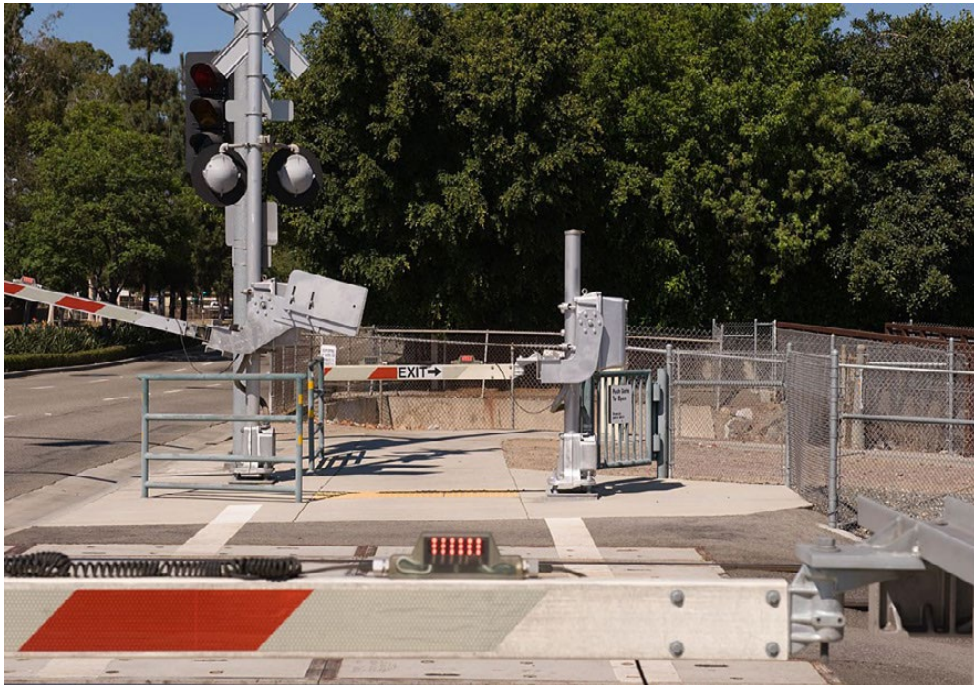
*Figure 1. Example of automatic pedestrian gate with emergency escape gate
Image Credit: FRA, Grade Crossing Handbook*

- Where automatic pedestrian gates are installed across pathway or sidewalk crossings, an emergency escape route should be available to provide egress away from the track area when the gates are activated. [2]

- An emergency exit route can be provided by use of a swing gate in combination with a pedestrian automatic gate. In this circumstance, the swing gate should be signed as an “Emergency Exit” on the track side and provided with a “DO NOT ENTER” (R5-1) sign on the side facing away from the tracks. [2]

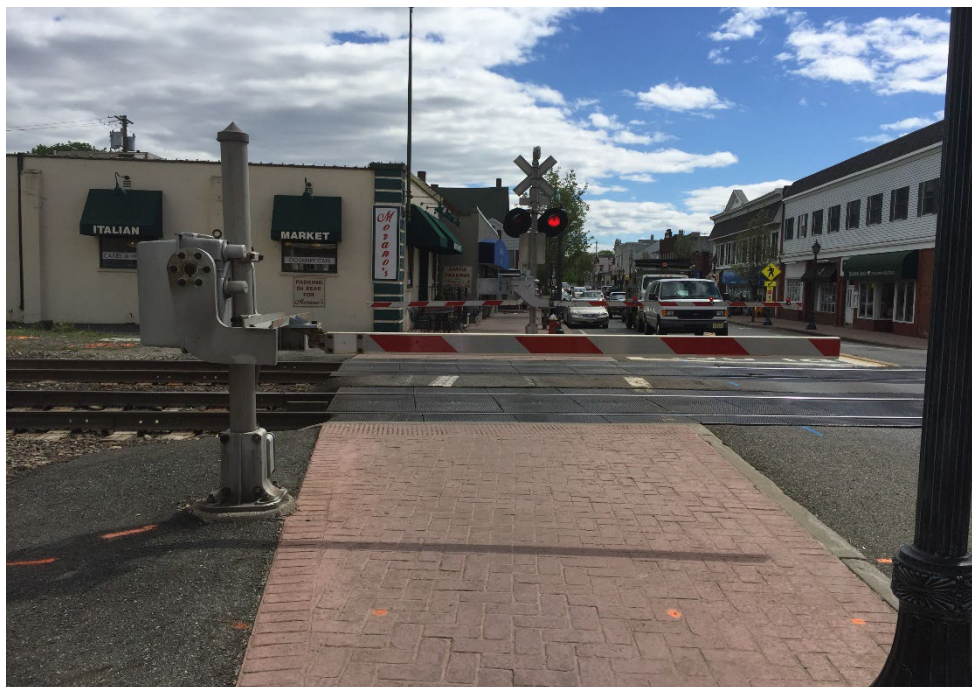
Figure 2. Example of automatic pedestrian gate in Ramsey, NJ
Image Credit: Volpe Center

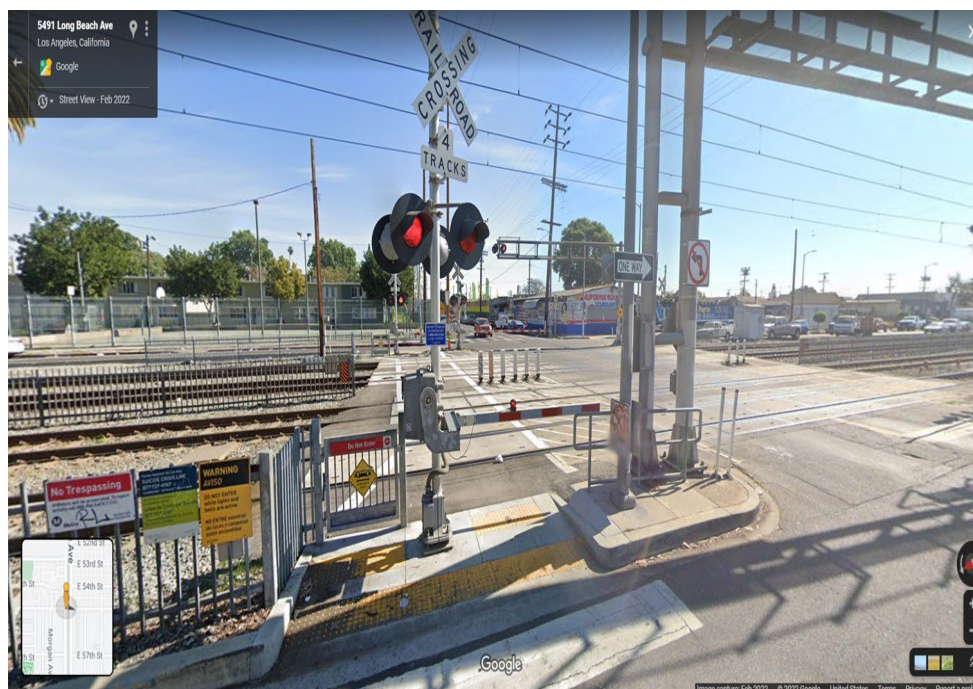
Figure 3. Automatic pedestrian gate from Google Street View

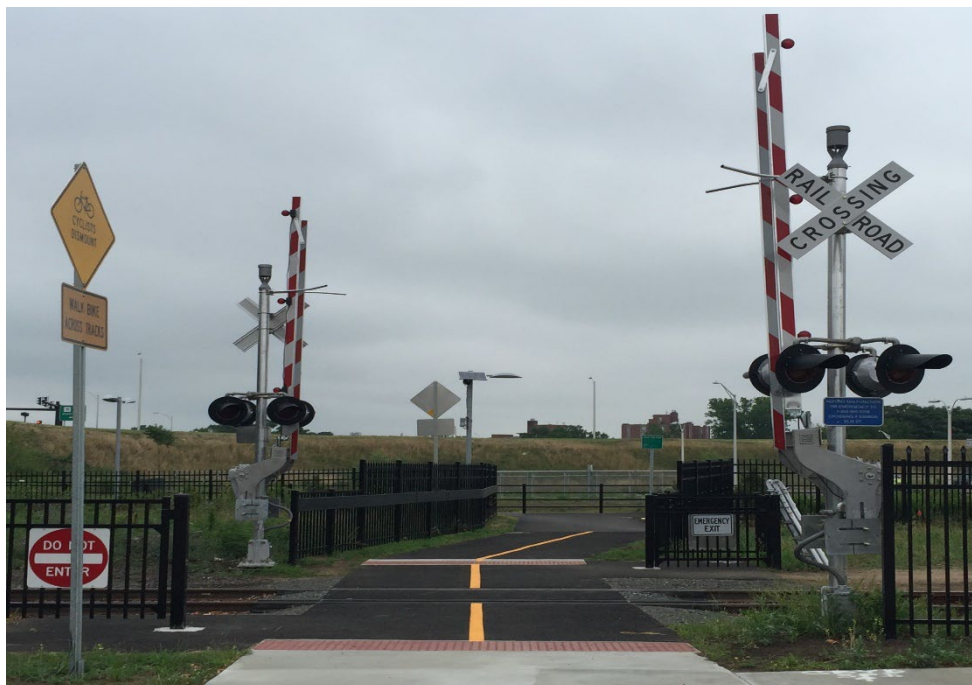
*Figure 4. Example of automatic pathway gate with emergency escape gate in New Britain, CT
Image Credit: Volpe Center*
