**Measure Name:** Pedestrian channelization

**Definition:** Installation of fencing, bedstead barriers, bollards, short posts with chains, landscaping, or oversized ballast on a sidewalk approach to a grade crossing to increase pedestrian safety.

## FRA Grade Crossing Toolkit: Pedestrian channelization

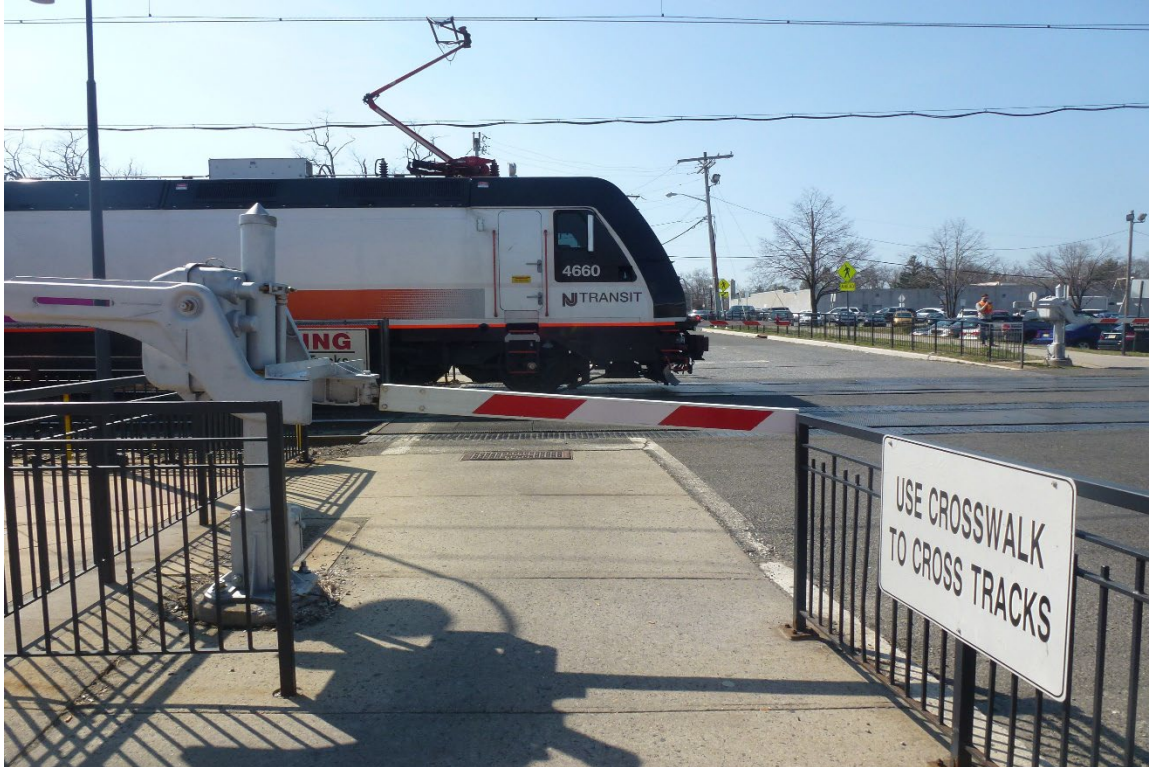
*Figure 1. Example of pedestrian channelization at a grade crossing in Matawan, NJ  
Image Credit: Volpe Center*

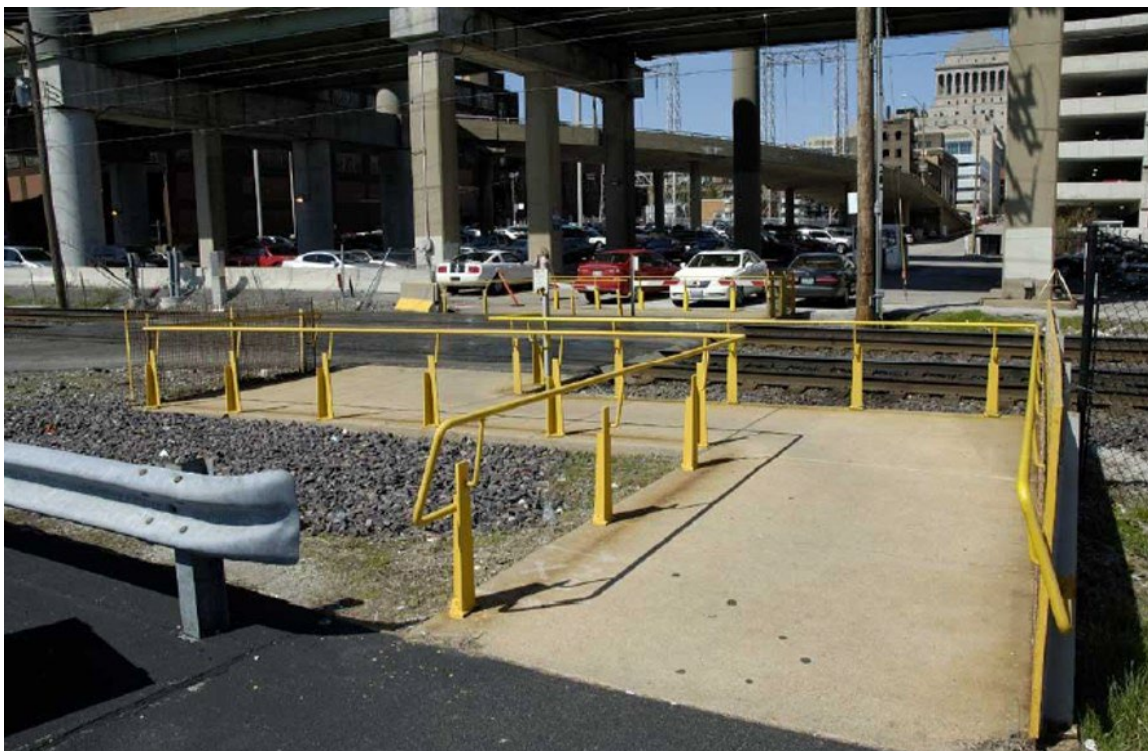
Figure 2. Example of pedestrian channelization

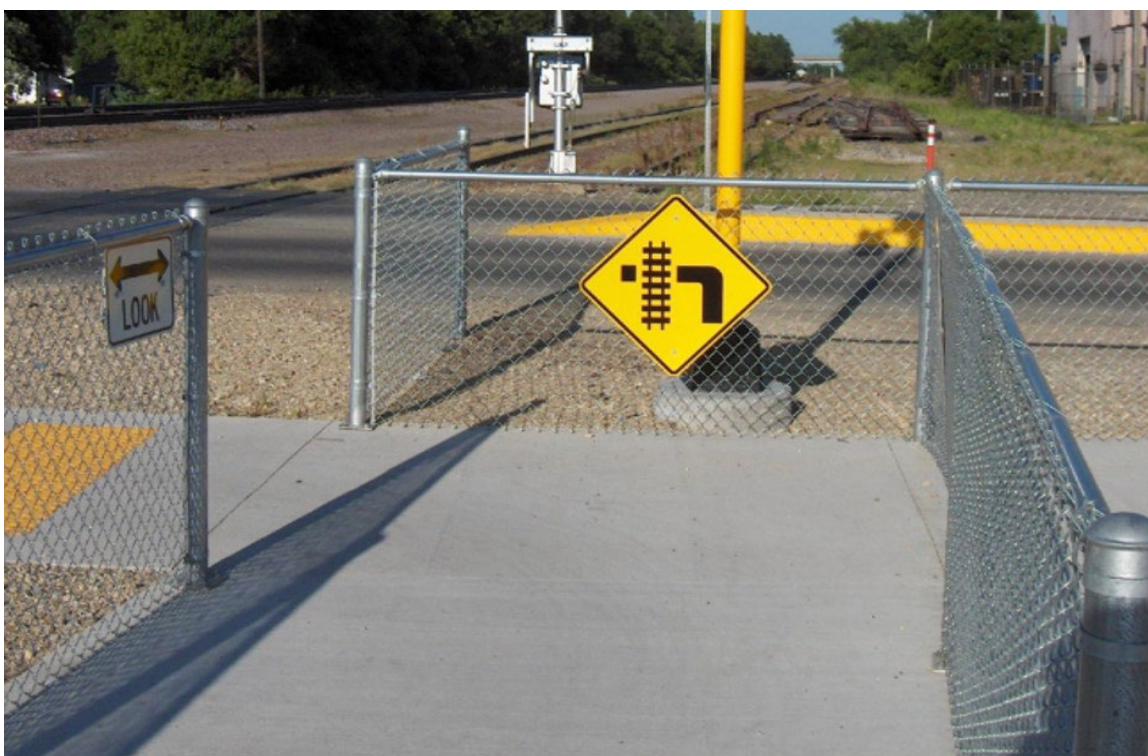
Figure 3. Example of pedestrian channelization

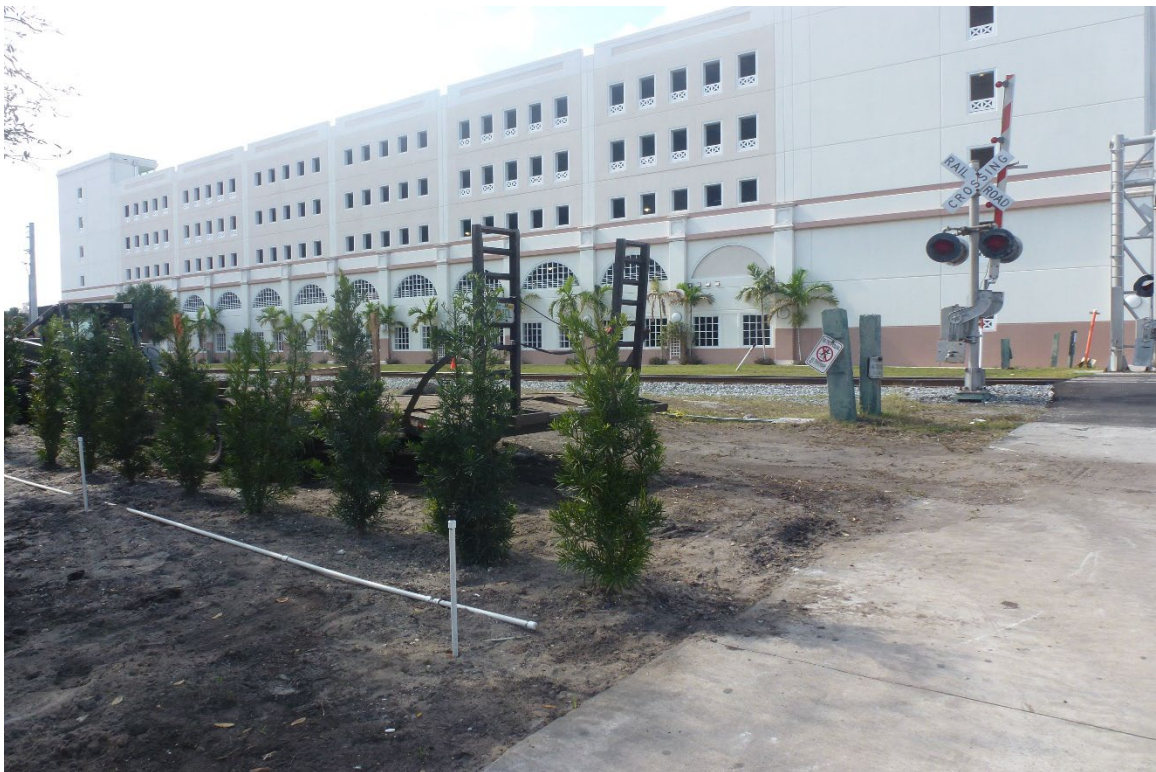
Figure 5. Example of pedestrian channelization using landscaping in West Palm Beach, FL  
Image Credit: Volpe Center

- Landscaping may take a few years before it becomes an effective channelization measure. [8]
- Landscaping must be maintained so it does not impede the visibility of any warning devices or signage by road users or railroad personnel. [8]

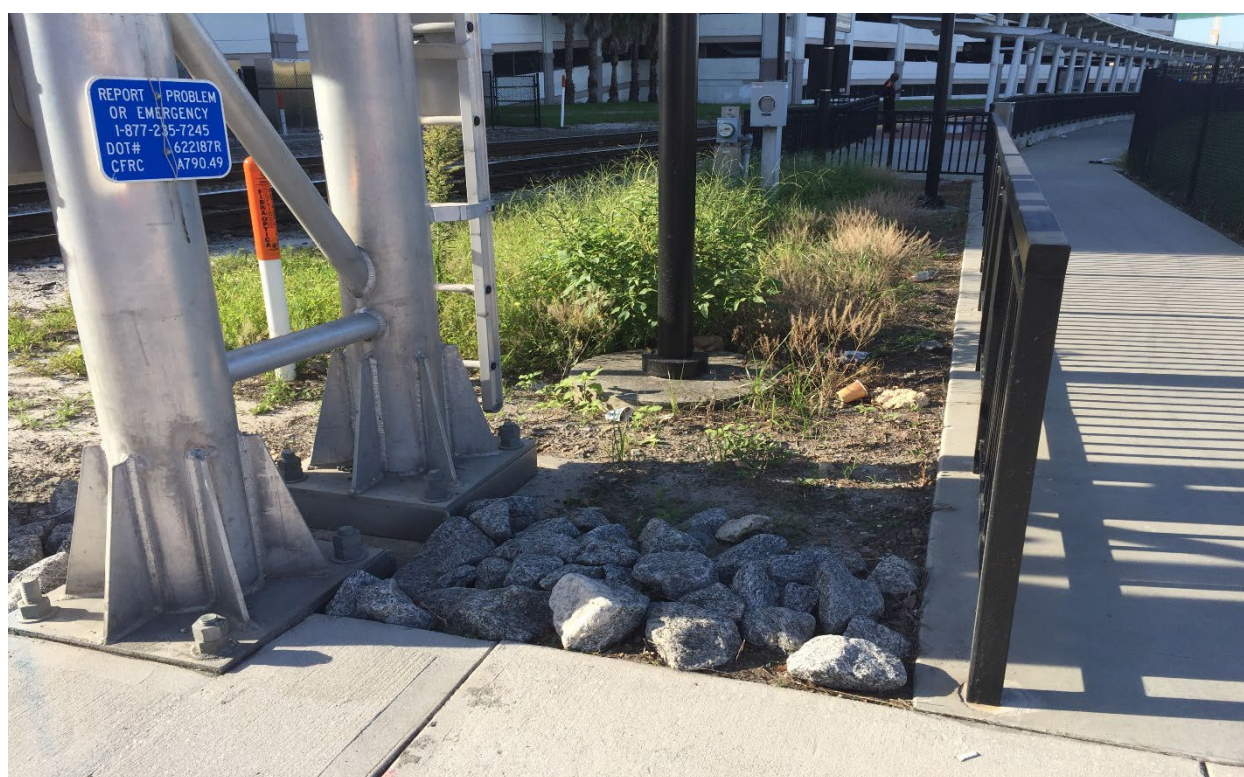
Figure 7. Example of pedestrian channelization using oversized ballast at a grade crossing in Orlando, FL  
Image Credit: Volpe Center
