## FRA Grade Crossing Toolkit: Rock treatments to restrict access

**Definition** Rocks installed alongside or across the tracks that make footing unreliable to deter or delay entry to the railroad right-of-way from a crossing.

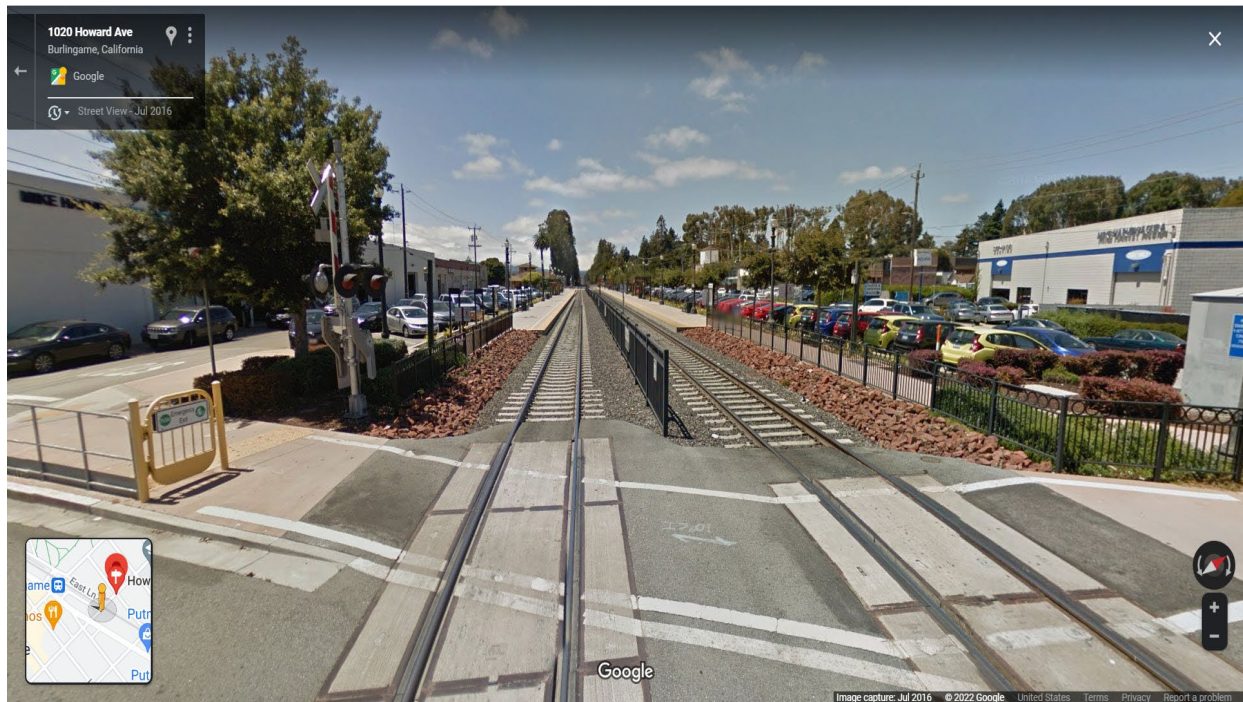
Figure 1. Example of rock treatments at a grade crossing in Burlingame, CA from Google Street View

This measure refers to installation of large, irregularly sized rocks on the ground outside of the tracks to prevent people from using the railroad right-of-way (ROW) as a shortcut to get onto the tracks. Unlike anti-trespass panels, the rocks can only be installed along the ROW outside the track gauge. In the U.S., rocks are most often installed at grade crossings that are close to train stations. These crossings tend to have train passengers using the ROW between the crossing and the station as a shortcut to the station platform.

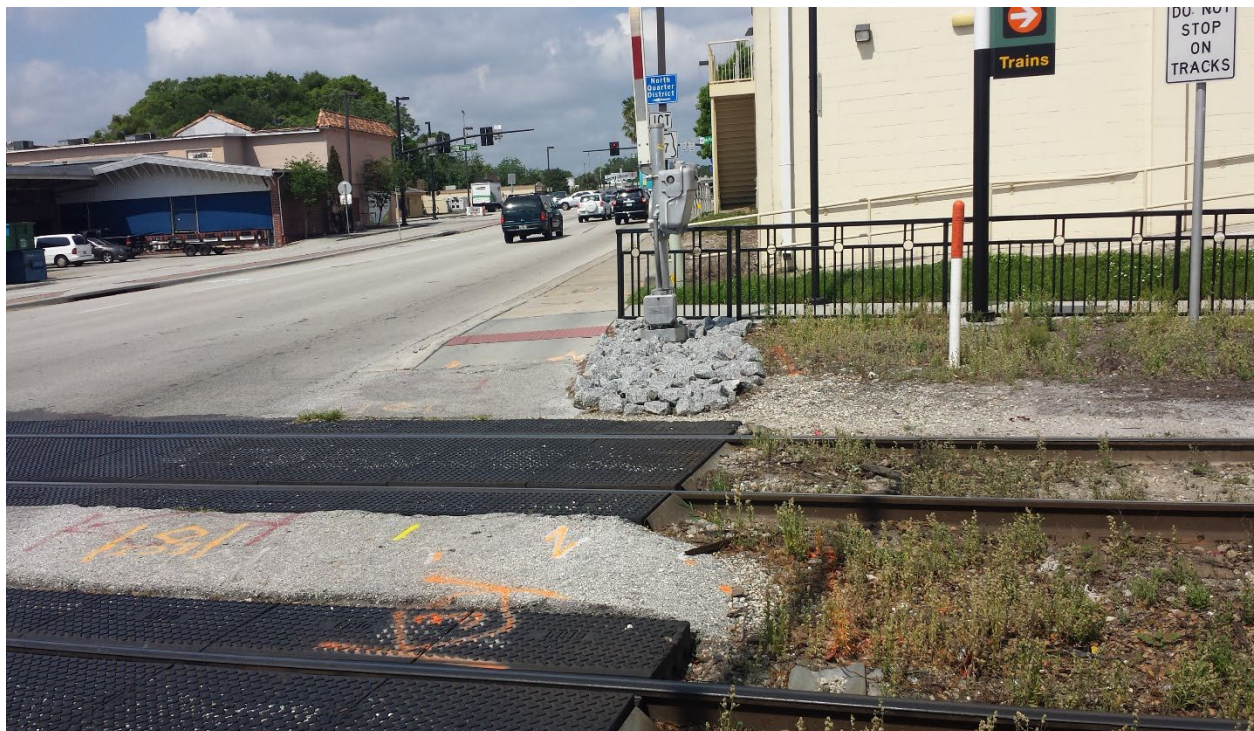
Figure 2. Example of rock treatments at a grade crossing in Orlando, FL  
Image Credit: Volpe Center

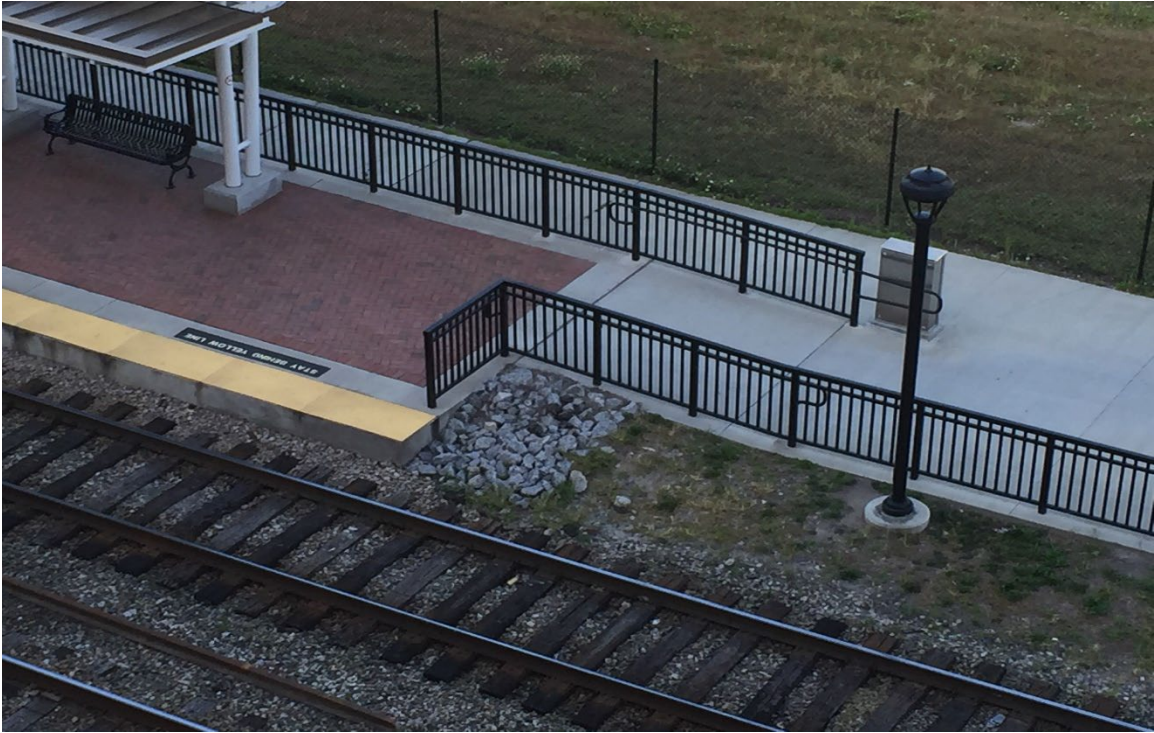
*Figure 3. Rock treatments to prevent commuters from using ROW as a shortcut between station and crossing.  
Image Credit: Volpe Center*

This measure is most effective when combined with proper channelization that prevents people from walking around the rocks or accidentally tripping and falling. The rocks should extend the entire length of the ROW from the crossing to the end of the platform, or they should be placed on a section of ROW at a grade crossing as well as towards the ends of the platform. The California Public Utilities Commission presents an alternative involving extending the ballasted area to the platform railing but notes that, if it proves ineffective, larger rocks should be placed to discourage walking on the ROW [1].
