Measure Name: Photo enforcement

Definition:Use of automated technology to capture photographic evidence of grade<br/>crossing violations to be used to enforce traffic laws.

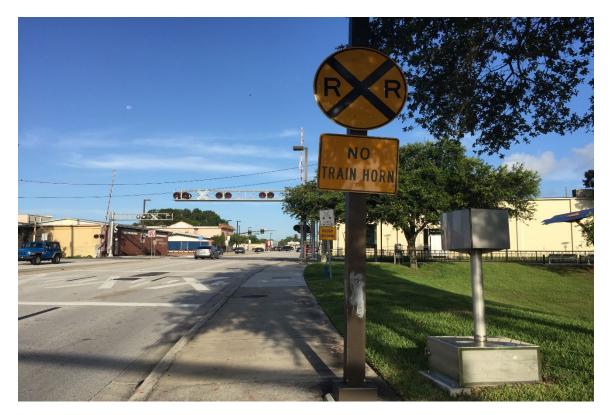
Figure 1. Photo enforcement system at a grade crossing in Orlando, FL Image Credit: Volpe Center

Photo enforcement is the use of automated technology to capture photographic evidence of traffic law violations at grade crossings; this evidence can be used to send warnings or penalties to drivers. This measure is intended to improve grade crossing safety by deterring grade crossing warning violations [1]. If a traffic law violation is detected, a fine or warning is typically mailed to the registered owner of the violating vehicle.

When a traffic law violation occurs at the location of a photo enforcement system, the system should collect information such as: images of the vehicle, the driver, the registration plate, and data such as the time, date, and location of the violation [2]. In the state of Illinois, if these criteria are met, then the local law enforcement agency can issue a citation, but requirements vary between states [2][3].

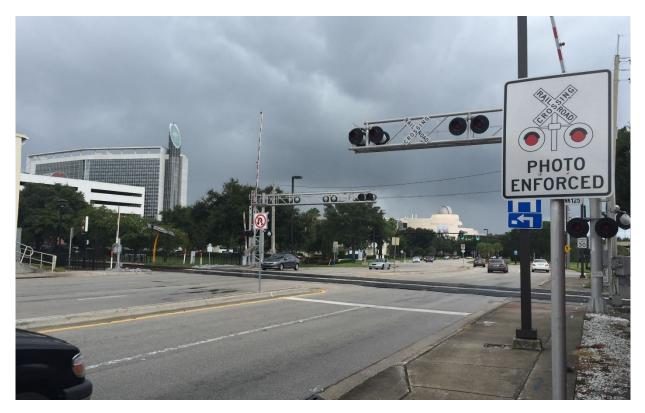
Figure 2. Example of a photo enforcement signage at a grade crossing in Orlando, FL Image Credit: Volpe Center
