**Measure Name:** Pedestrian channelization

**Definition:** Installation of fencing, bedstead barriers, bollards, short posts with chains, landscaping, or oversized ballast on a sidewalk approach to a grade crossing to increase pedestrian safety.

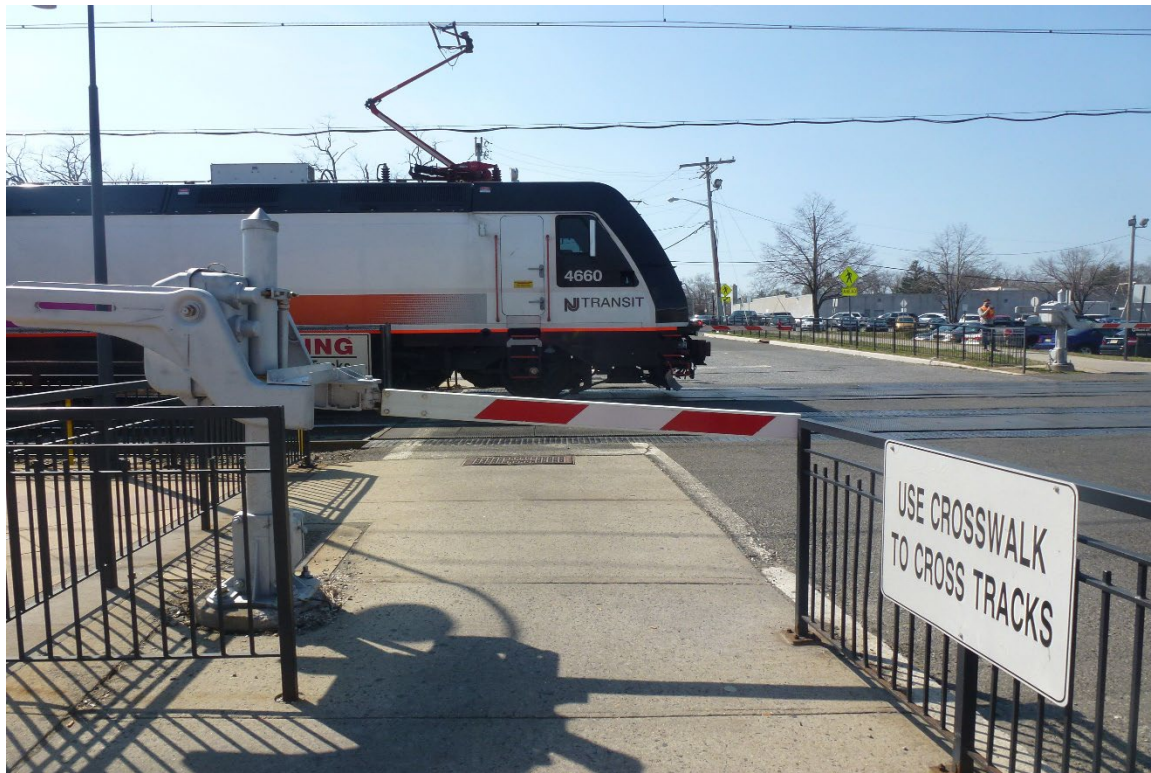
*Figure 1. Example of pedestrian channelization at a grade crossing in Matawan, NJ  
Image Credit: Volpe Center*

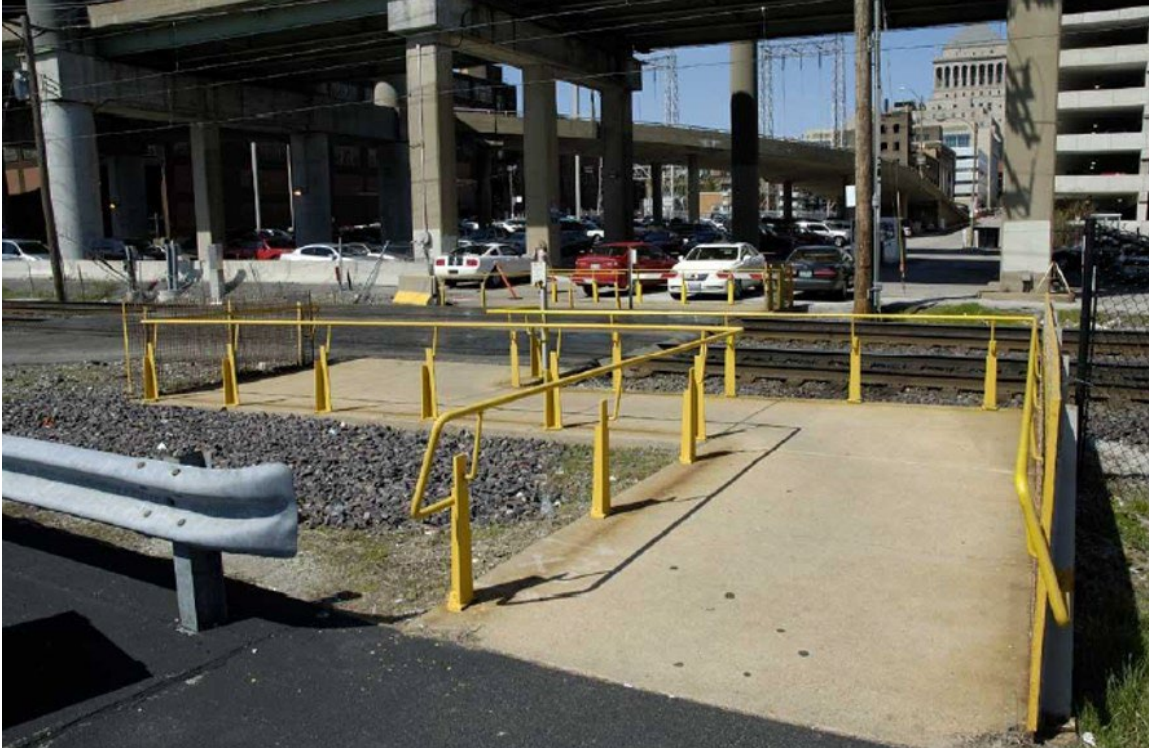
Figure 2. Example of pedestrian channelization  
Image Credit: FRA, [Compilation of Pedestrian Safety Devices In Use at Grade Crossings](#)

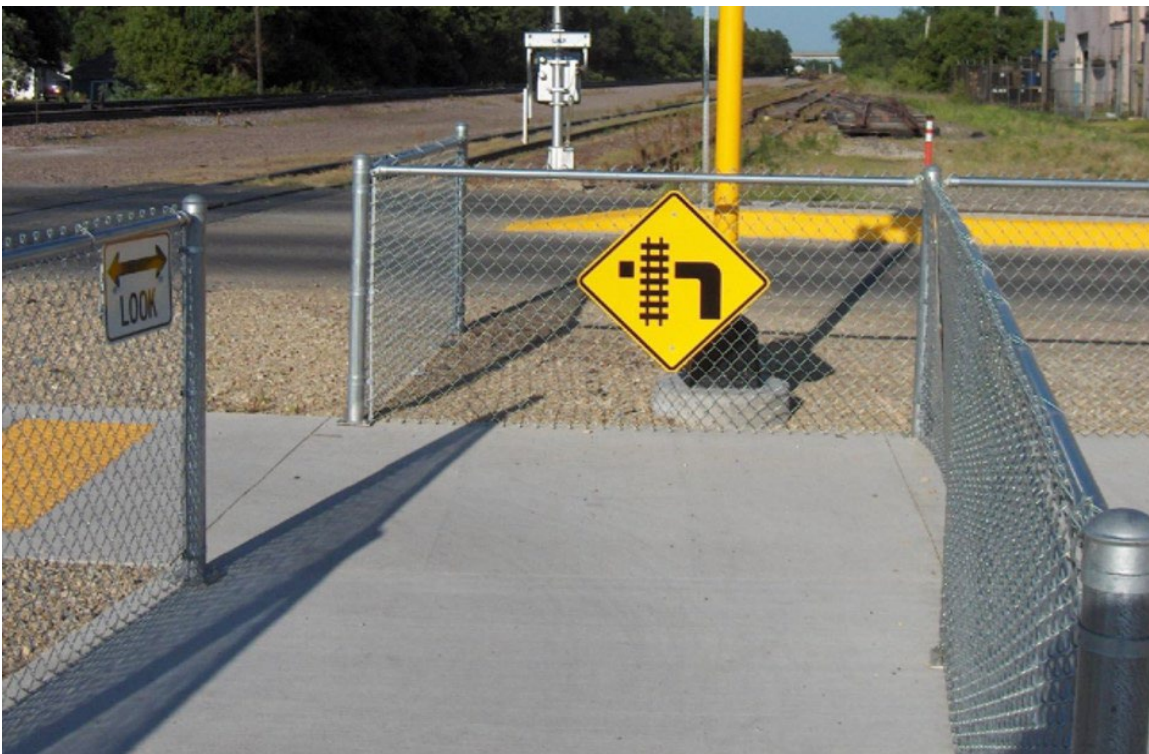
Figure 3. Example of pedestrian channelization  
Image Credit: FRA, [Guidance on Pedestrian Crossing Safety at or near Passenger Stations, 2012](#)

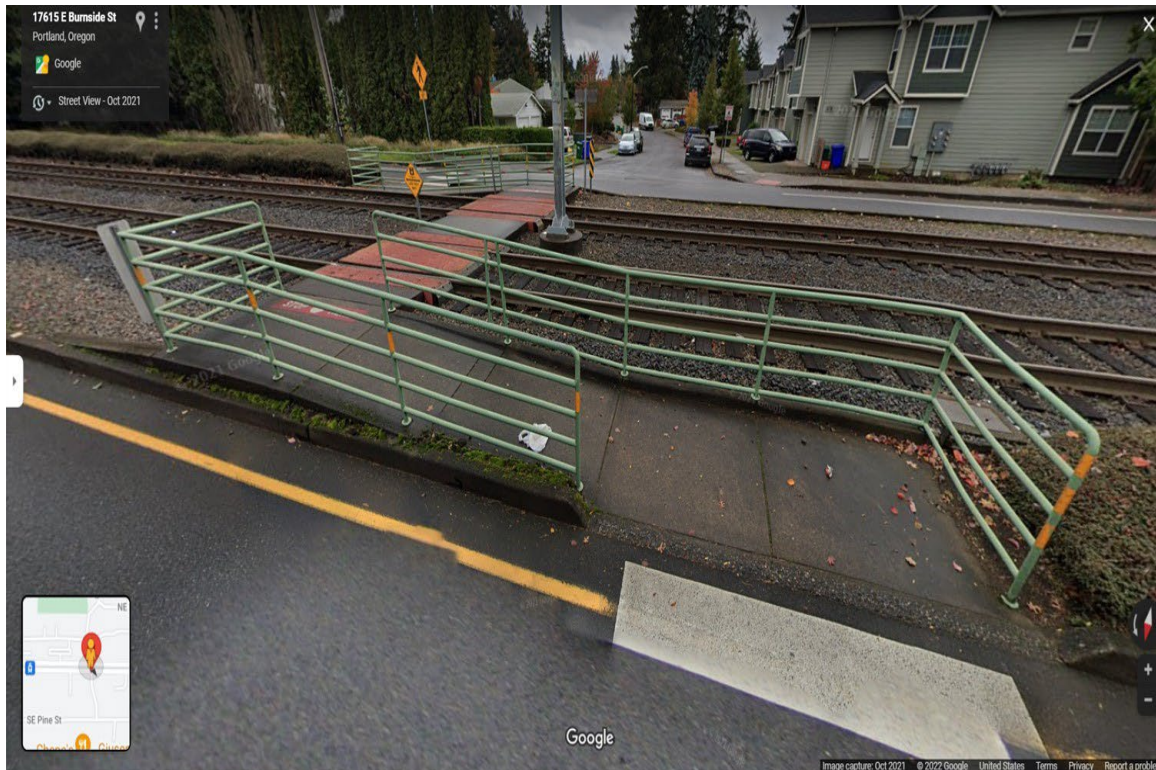
Figure 4. Example of pedestrian channelization from Google Street View

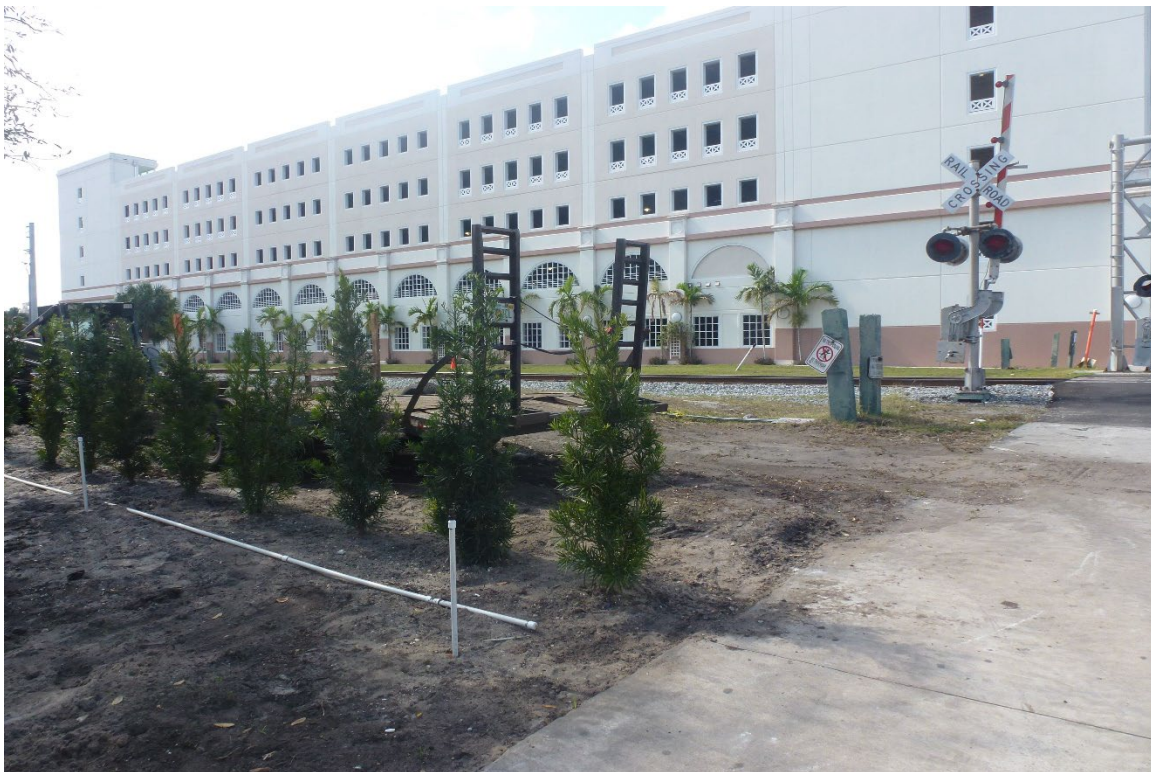
Figure 5. Example of pedestrian channelization using landscaping in West Palm Beach, FL  
Image Credit: Volpe Center

- Landscaping may take a few years before it becomes an effective channelization measure. [8]
- Landscaping must be maintained so it does not impede the visibility of any warning devices or signage by road users or railroad personnel. [8]

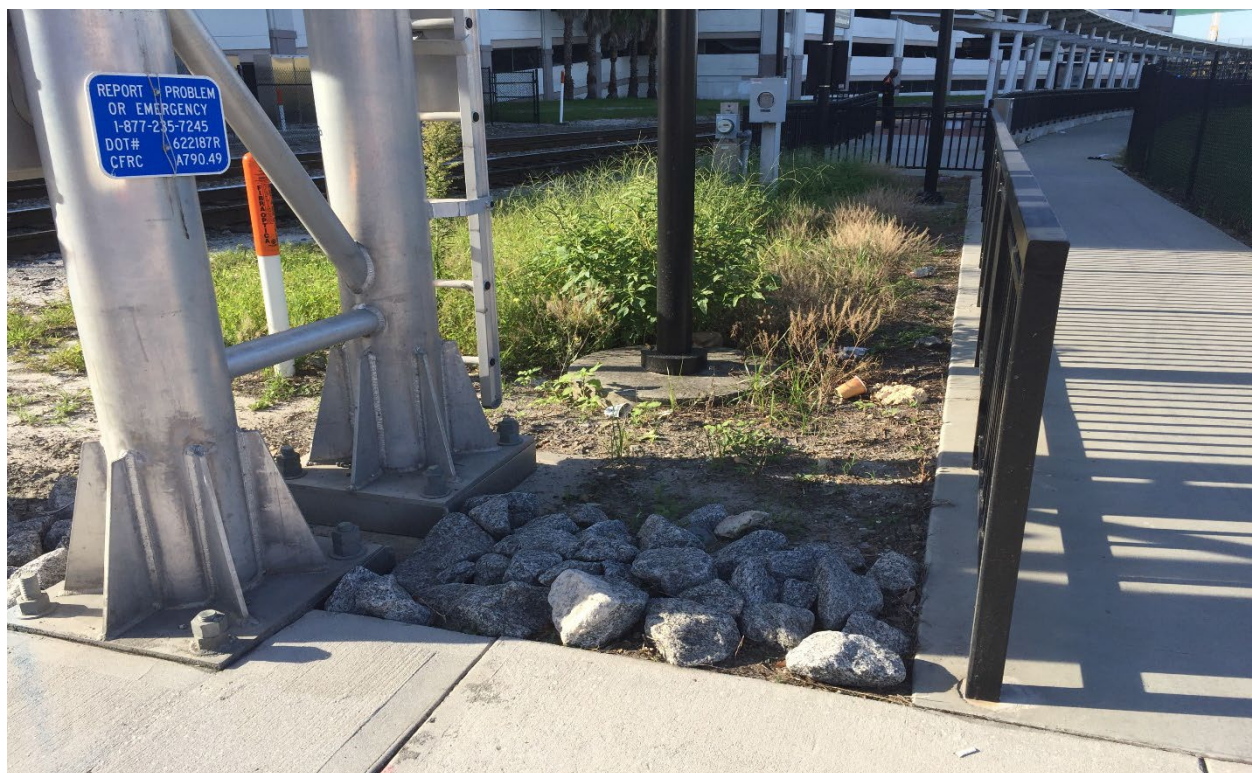
Figure 7. Example of pedestrian channelization using oversized ballast at a grade crossing in Orlando, FL  
Image Credit: Volpe Center
