**Measure Name**      Rock treatments to restrict access

**Definition**              Rocks installed alongside or across the tracks that make footing unreliable to deter or delay entry to the railroad right-of-way from a crossing.

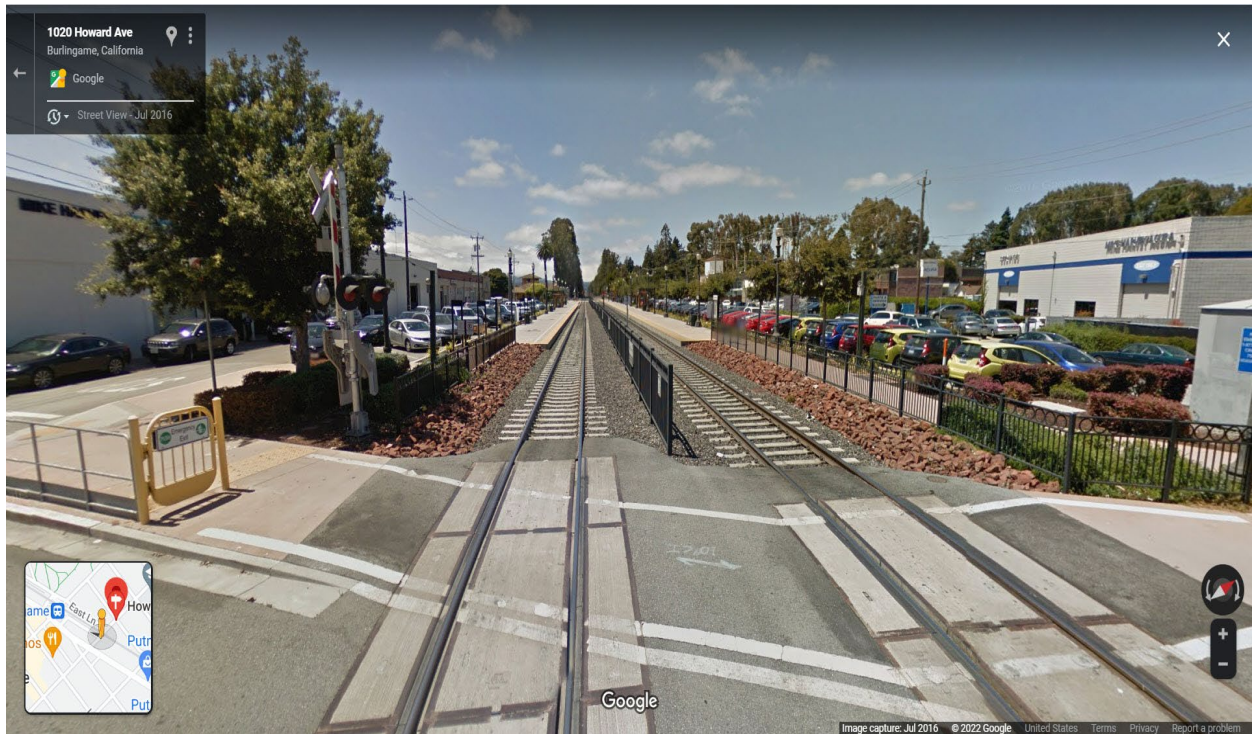
Figure 1. Example of rock treatments at a grade crossing in Burlingame, CA from Google Street View

This measure refers to installation of large, irregularly sized rocks on the ground outside of the tracks to prevent people from using the railroad right-of-way (ROW) as a shortcut to get onto the tracks. Unlike anti-trespass panels, the rocks can only be installed along the ROW outside the track gauge. In the U.S., rocks are most often installed at grade crossings that are close to train stations. These crossings tend to have train passengers using the ROW between the crossing and the station as a shortcut to the station platform.

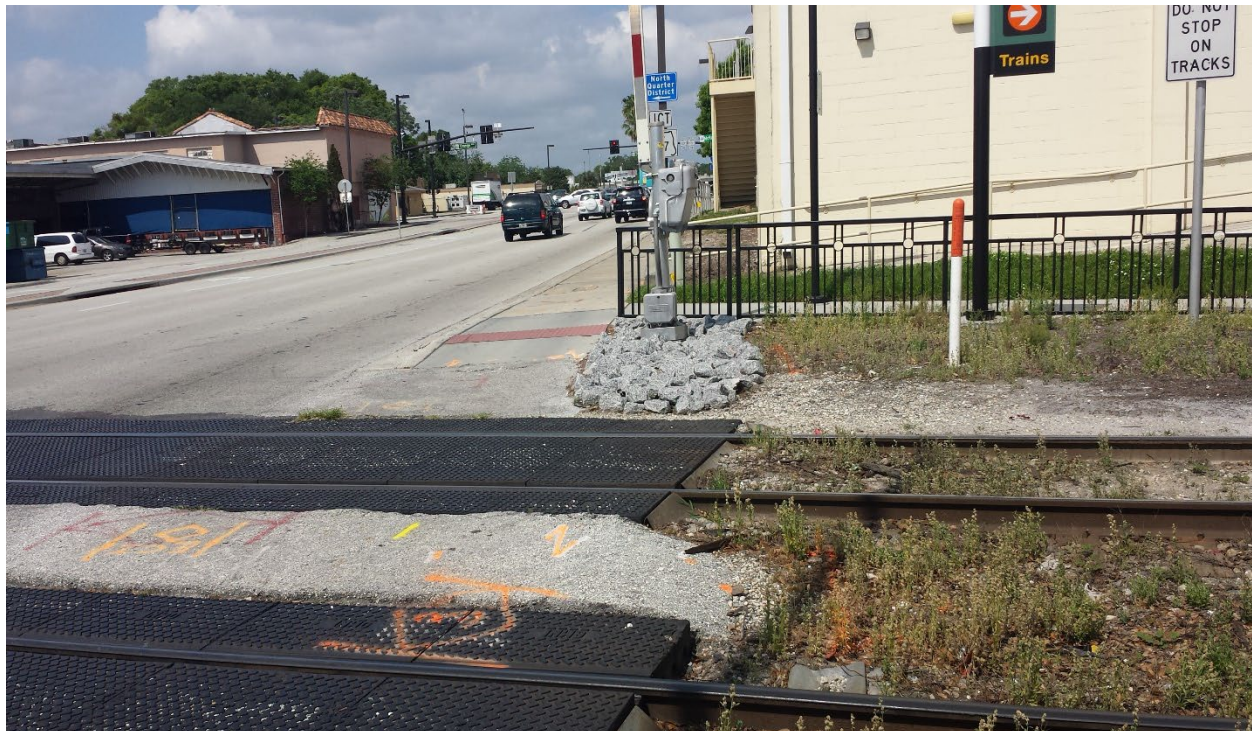
Figure 2. Example of rock treatments at a grade crossing in Orlando, FL  
Image Credit: Volpe Center

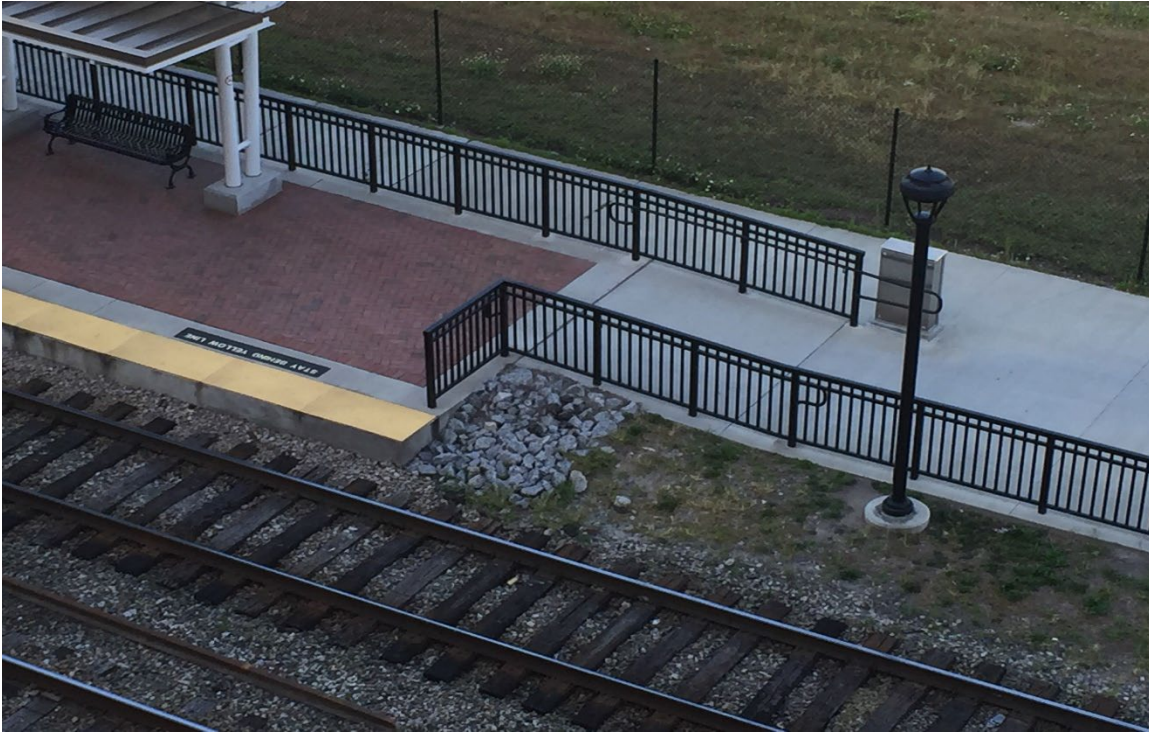
*Figure 3. Rock treatments to prevent commuters from using ROW as a shortcut between station and crossing.  
Image Credit: Volpe Center*

This measure is most effective when combined with proper channelization that prevents people from walking around the rocks or accidentally tripping and falling. The rocks should extend the entire length of the ROW from the crossing to the end of the platform, or they should be placed on a section of ROW at a grade crossing as well as towards the ends of the platform. The California Public Utilities Commission presents an alternative involving extending the ballasted area to the platform railing but notes that, if it proves ineffective, larger rocks should be placed to discourage walking on the ROW [1].
