Measure Name: Photo enforcement

Definition: Use of automated technology to capture photographic evidence of grade crossing violations to be used to enforce traffic laws.

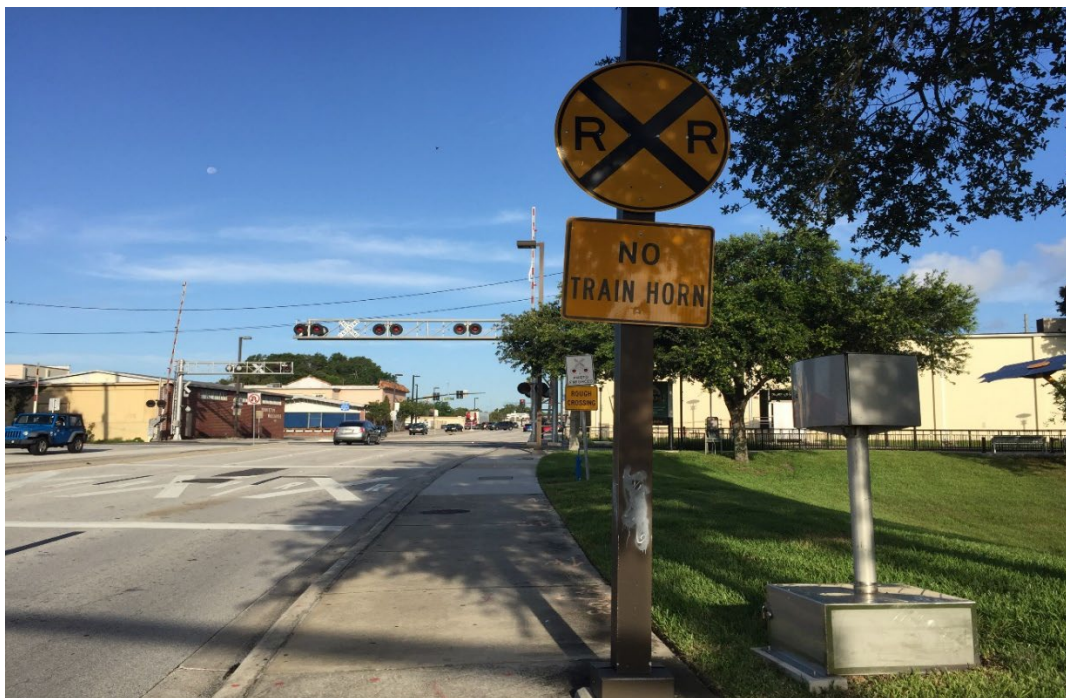
Figure 1. Photo enforcement system at a grade crossing in Orlando, FL
Image Credit: Volpe Center

Photo enforcement is the use of automated technology to capture photographic evidence of traffic law violations at grade crossings; this evidence can be used to send warnings or penalties to drivers. This measure is intended to improve grade crossing safety by deterring grade crossing warning violations [1]. If a traffic law violation is detected, a fine or warning is typically mailed to the registered owner of the violating vehicle.

When a traffic law violation occurs at the location of a photo enforcement system, the system should collect information such as: images of the vehicle, the driver, the registration plate, and data such as the time, date, and location of the violation [2]. In the state of Illinois, if these criteria are met, then the local law enforcement agency can issue a citation, but requirements vary between states [2][3].

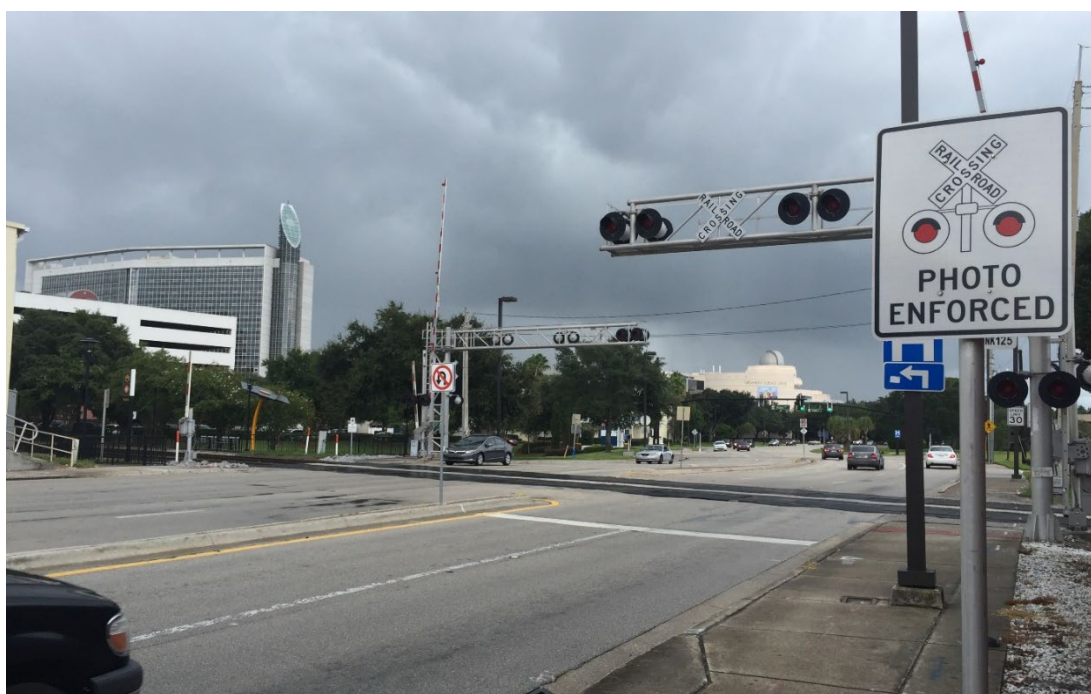
Figure 2. Example of a photo enforcement signage at a grade crossing in Orlando, FL
Image Credit: Volpe Center
