**Measure Name:** Automatic pedestrian gate

**Definition:** Installation of automatic pedestrian gates at active grade crossings.

## FRA Grade Crossing Toolkit: Automatic pedestrian gate

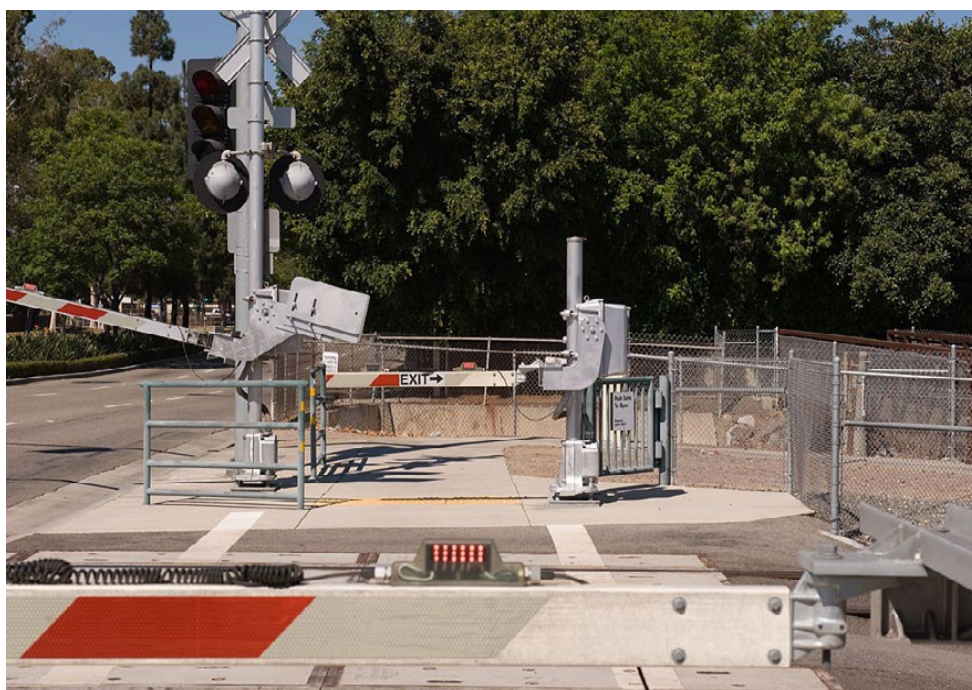
*Figure 1. Example of automatic pedestrian gate with emergency escape gate*  
Image Credit: [Highway-Rail Crossing Handbook](#)

- Where automatic pedestrian gates are installed across pathway or sidewalk crossings, an emergency escape route should be available to provide egress away from the track area when the gates are activated. [2]

- An emergency exit route can be provided by use of a swing gate in combination with a pedestrian automatic gate. In this circumstance, the swing gate should be signed as an “Emergency Exit” on the track side and provided with a “DO NOT ENTER” (R5-1) sign on the side facing away from the tracks. [2]

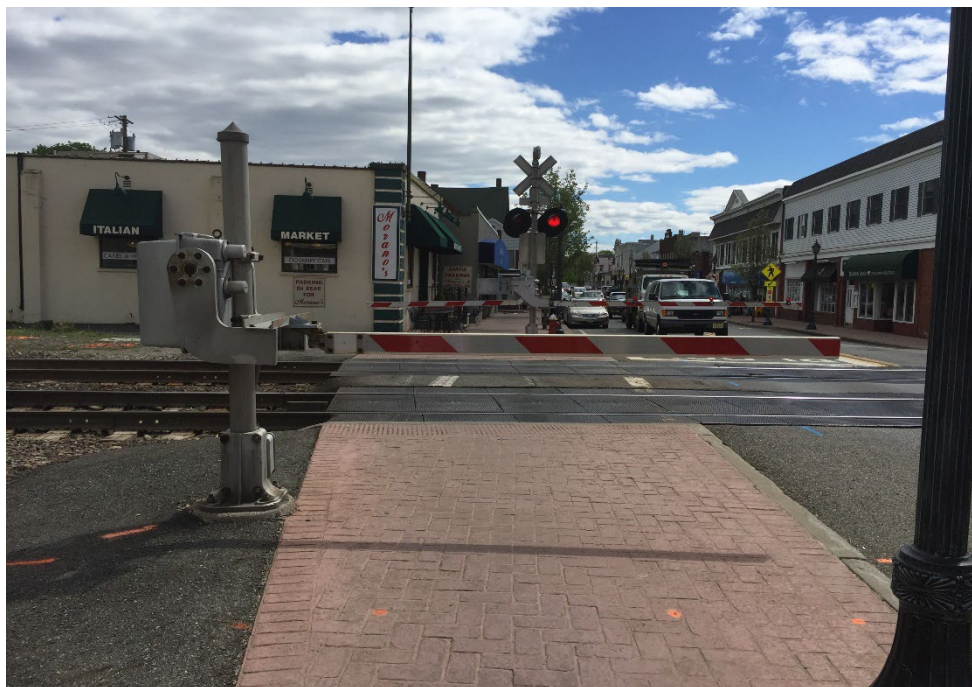
Figure 2. Example of automatic pedestrian gate in Ramsey, NJ  
Image Credit: Volpe Center

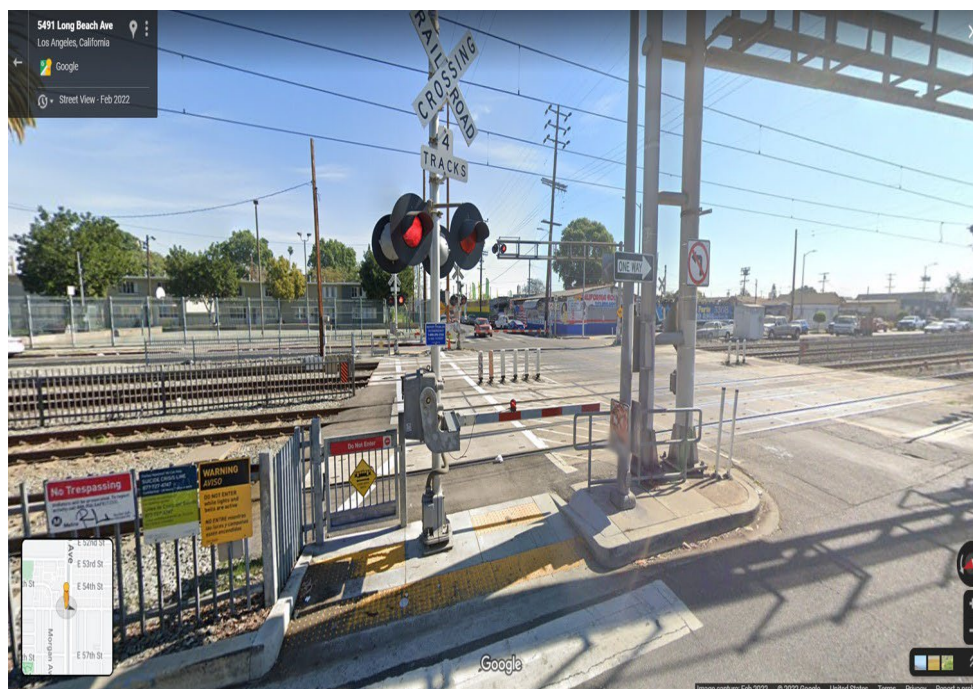
Figure 3. Automatic pedestrian gate from Google Street View

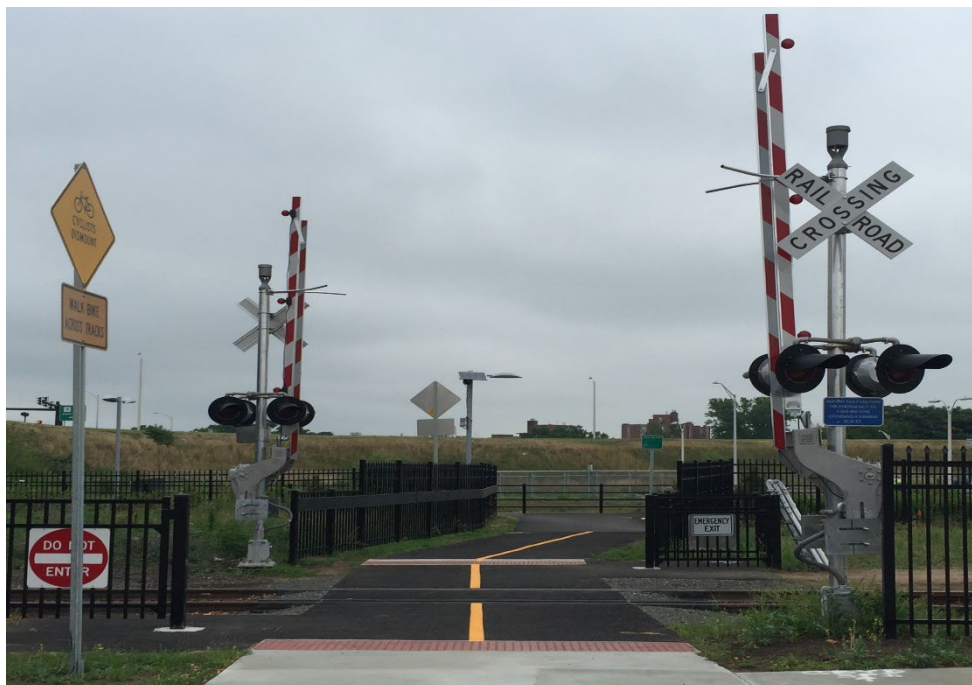
*Figure 4. Example of automatic pathway gate with emergency escape gate in New Britain, CT  
Image Credit: Volpe Center*
