**Measure Name:** Photo enforcement

**Definition:** Use of automated technology to capture photographic evidence of grade crossing violations to be used to enforce traffic laws.

## FRA Grade Crossing Toolkit: Photo enforcement

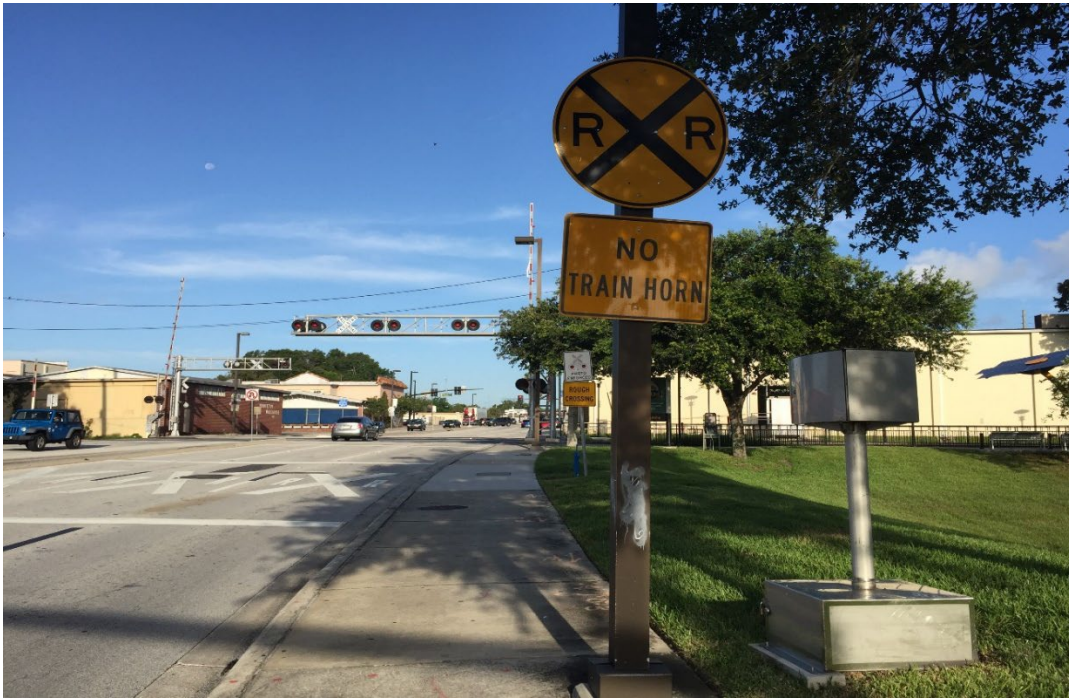
Figure 1. Photo enforcement system at a grade crossing in Orlando, FL  
Image Credit: Volpe Center

When a traffic law violation occurs at the location of a photo enforcement system, the system should collect information such as: images of the vehicle, the driver, the registration plate, and data such as the time, date, and location of the violation [2]. In the state of Illinois, if these criteria are met, then the local law enforcement agency can issue a citation, but requirements vary between states [2][3].

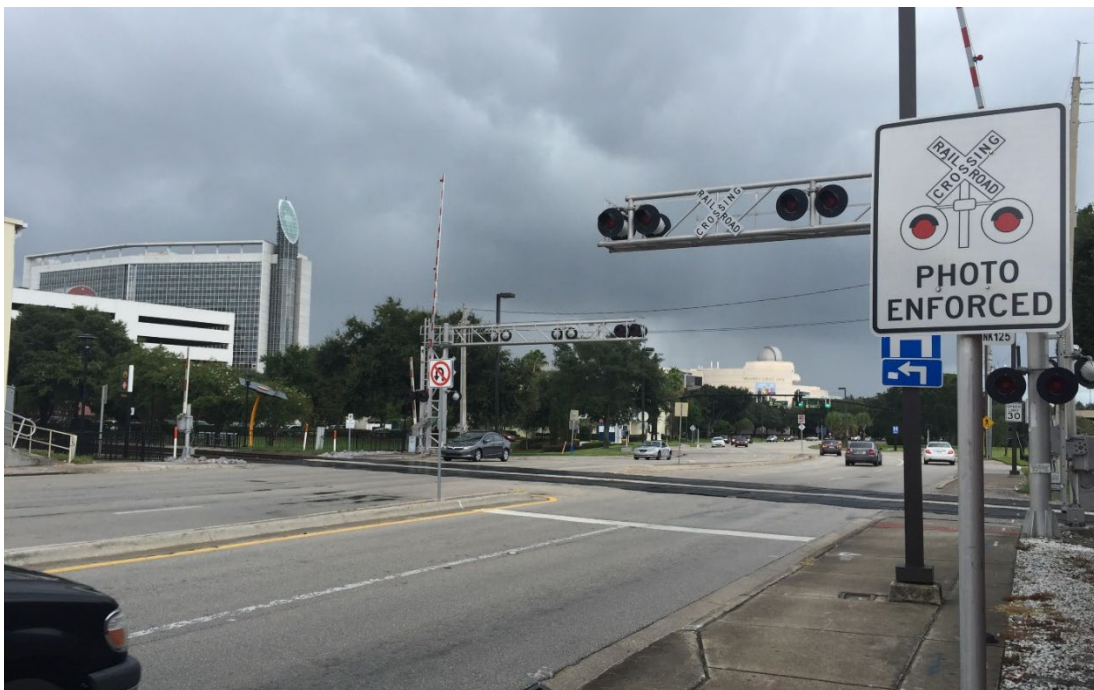
Figure 2. Example of photo enforcement signage at a grade crossing in Orlando, FL  
Image Credit: Volpe Center
